**Examination of Poly Implant Prothèse
(PIP) silicone breast implant retrieval
study by Swarts *et al* (2012)**

**Quality First International
February 2013**

Examination of Poly Implant Prothèse (PIP) silicone breast implant retrieval study by Swarts *et al* (2012)

Haroon Atchia, Chief Executive Officer & Technical Director, Quality First International

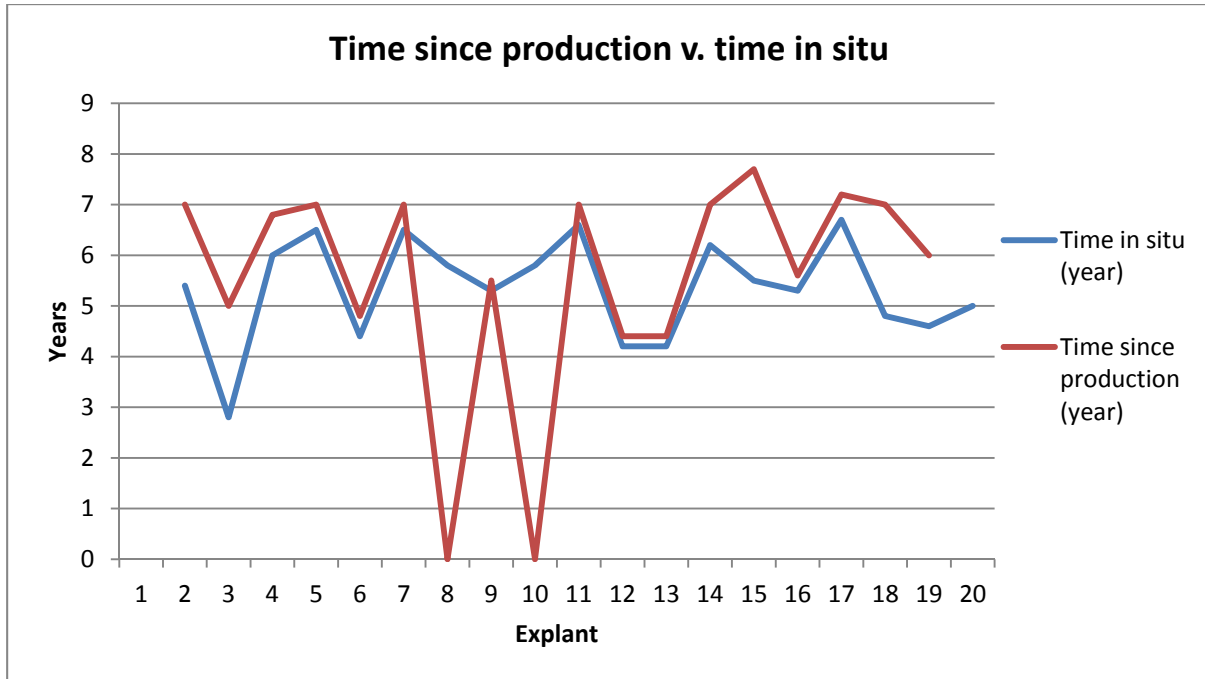
Information in Table 3 was plotted in order to reveal existence of time dependence (Figure 5 Time since production v. time *in situ*). Total time *in situ* was 101.6 (32.8 left breast implants and 68.8 right breast implants) (mean 5.35) years. There is little evidence suggesting significant difference in longevity between left and right breast implants. Unfortunately, time since production was unknown for implants 8, 10 and 19. Index of average time since production *versus* time *in situ* suggests horizontal linearity, however efforts to establish time dependence on data available in the research by Swarts *et al* (2012) proved difficult for several reasons. Since certain information on implants number 7 and 9 was incomplete, they were excluded from calculation of linear average attempting to investigate any relation between durability of implants in the series. Figure 6 indicates a central tendency about respective medians around 6 years since production and 5 years *in situ* time (but interpretation is far from conclusive).

Figure 5 Examination of time to failure from data from Swarts *et al* (2012) on retrieved
